# Results From an Integrated Optical/Acoustic Communication System Installed at CORK 857D: Implications for Future Observatories

Maurice Tivey, Norman Farr, Jonathan Ware and Clifford Pontbriand • Woods Hole Oceanographic Institution, Woods Hole, MA 02543

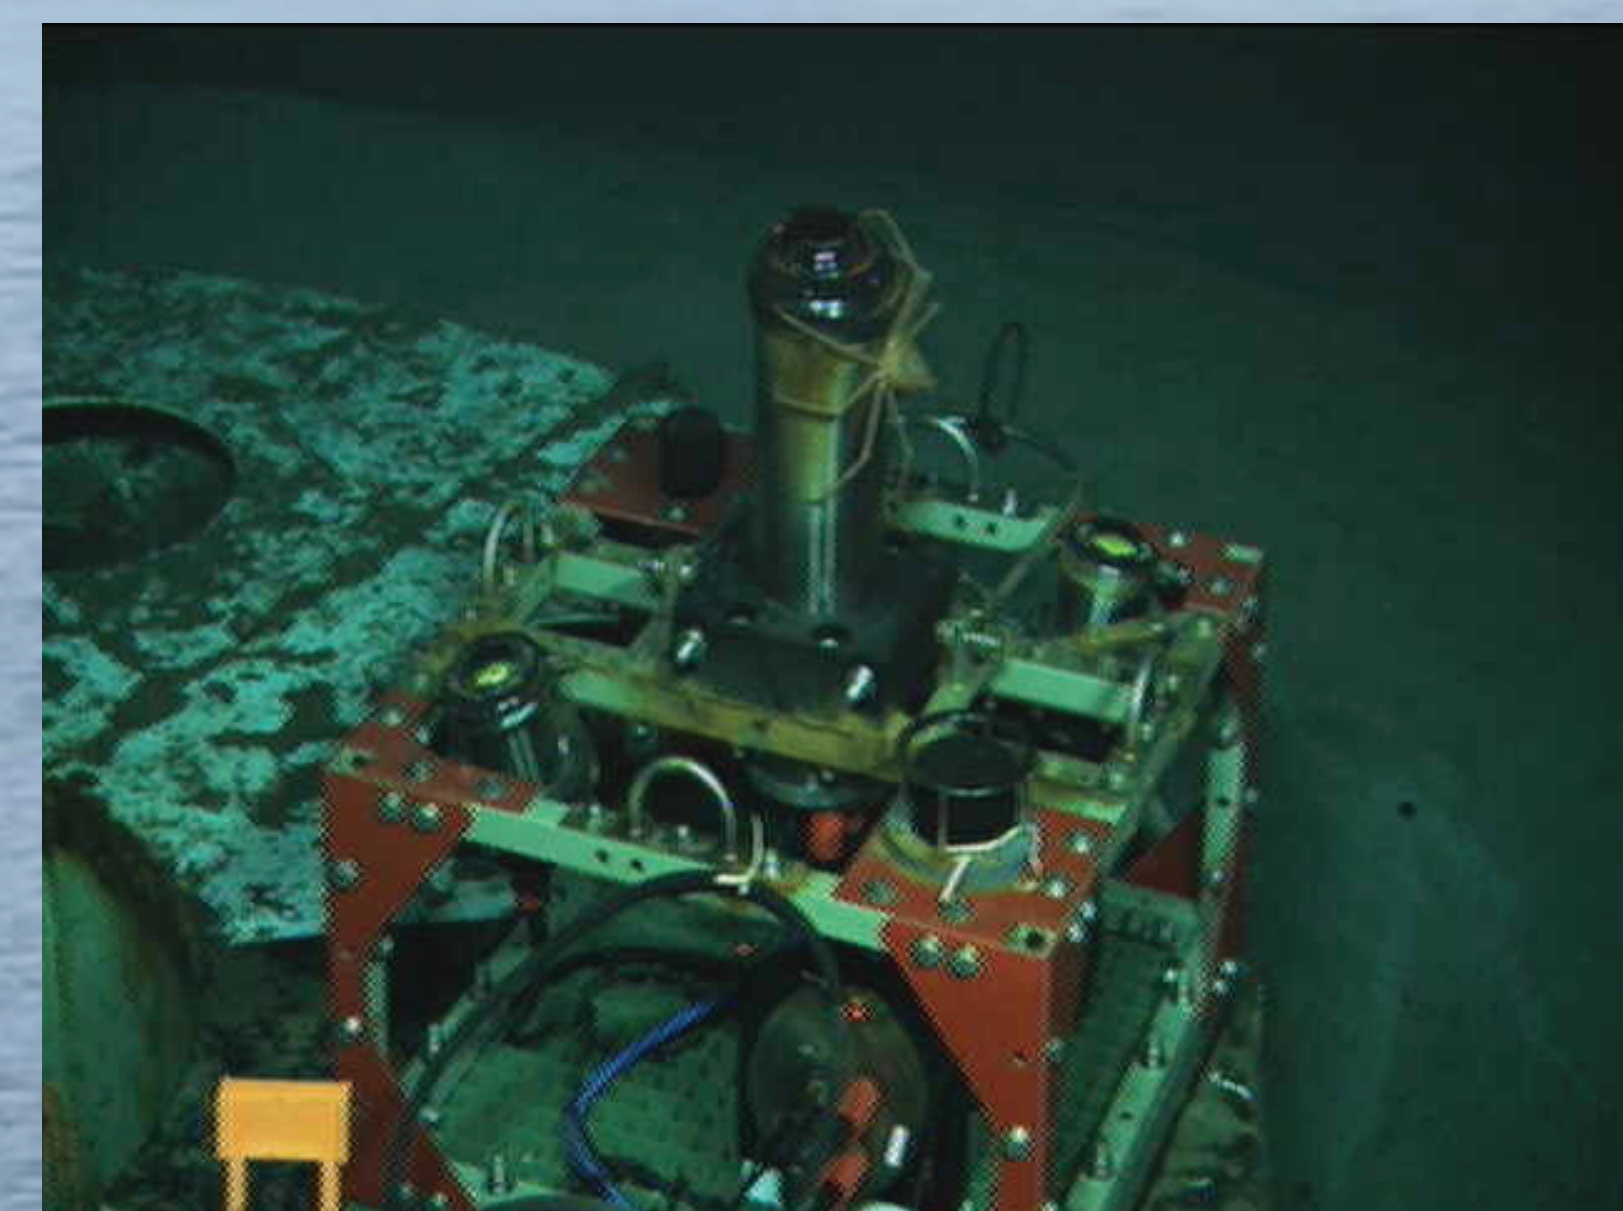
### OTS / Seafloor system

The Seafloor system connects to the previously installed CORK data logger via an underwater-mateable connector. This is the same connector used to offload data from the CORK to a submersible. An optical receiver / controller are installed on the lander frame, as well as an acoustic modem, optical emitters, and a battery housing.

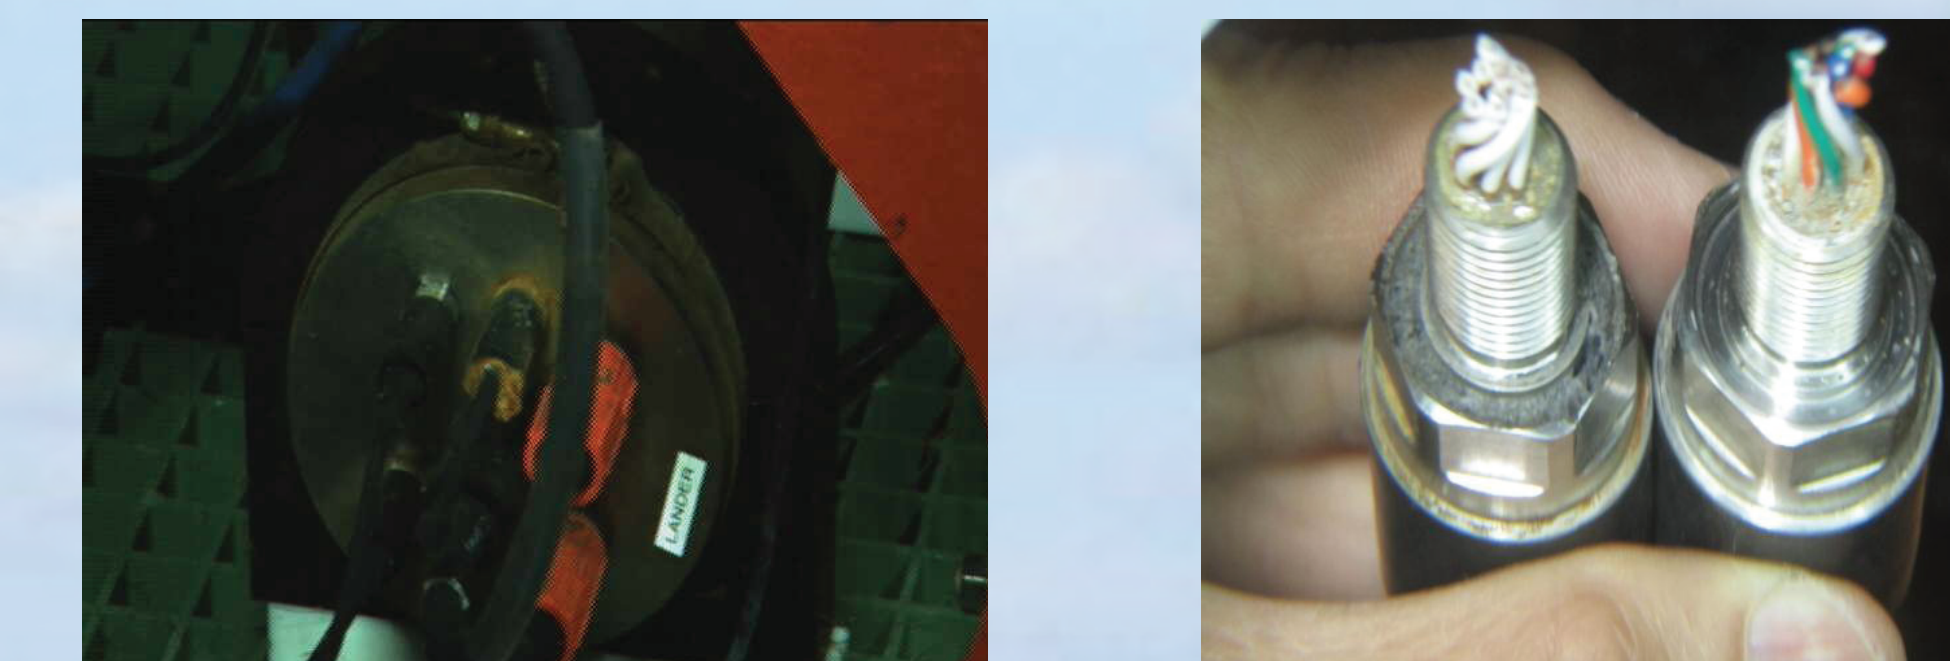
Upon arrival after over a year's deployment, we were unable to acoustically wake or ping the CORK OTS / data logger lander from the lowered OTS. The 857 D CORK site was dove on with the Jason ROV to visually inspect the lander, finding little biofouling, but signs of corrosion on the lander frame and housing connectors. Water was observed inside one of the emitter housings through its glass dome end cap. Suspecting a leak in our battery housing, the entire lander was recovered.

All four of pressure vessels were found to be flooded with brown sludge inside the housings. The problem was traced to anoxic crevice (pitting) corrosion of the stainless steel connectors, and subsequent bacterial cultures revealed sulfate reducing bacteria.

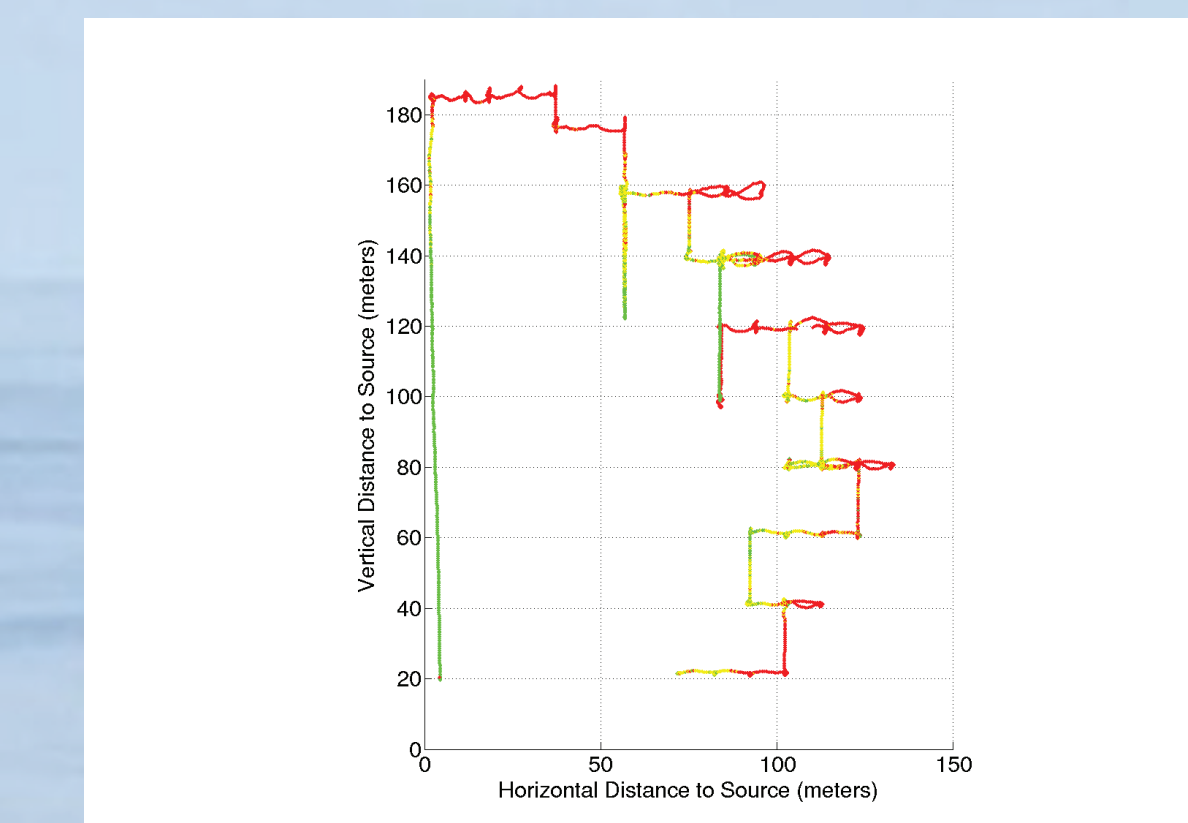
A plot of optical communications extent, lower left, shows an example of one wavelength / radiance pattern. Red on the plot represents high bit errors and no data link. The maximum range achieved for 1 Mbps data rate was 180 meters using a blue (450nm) emitter. This is typical of all wavelengths tested.

Video transmission was verified on subsequent JASON dives from the lander to an optical receiver mounted on JASON's Medea.
